ECR2 Source Upgrade

D. P. May, G. J. Derrig, F. P. Abegglen, W. H. Peeler, and W. L. Dewees

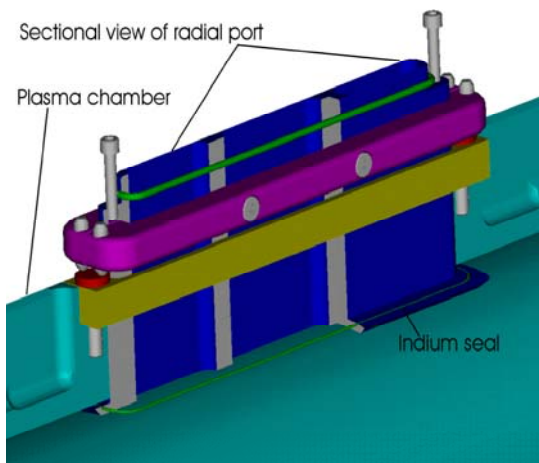
Figure 1: Stainless steel radial port plasma chamber insert. One of three, spaced 120° apart.

In order to accomplish this without sacrificing too much of the pole strength at the walls, the original chamber was machined to a larger ID, so that it could still function as the hexapole holder. Then a liner with an ID of 13.0 cm. was fabricated with seven water channels over the inner face of each hexapole bar. Both the liner and the hexapole holder were machined to accept three stainless steel inserts that function as radial ports (Fig. 1).

Indium o-rings between the flanges of the inserts and the inside of the liner form vacuum-water seals while viton o-rings fitting around the inserts form water-air seals. The seals are compressed via screws accessible from the outside of the assembly.
