## HPGe detector pumping/temperature history

V.E. Iacob and J.C. Hardy

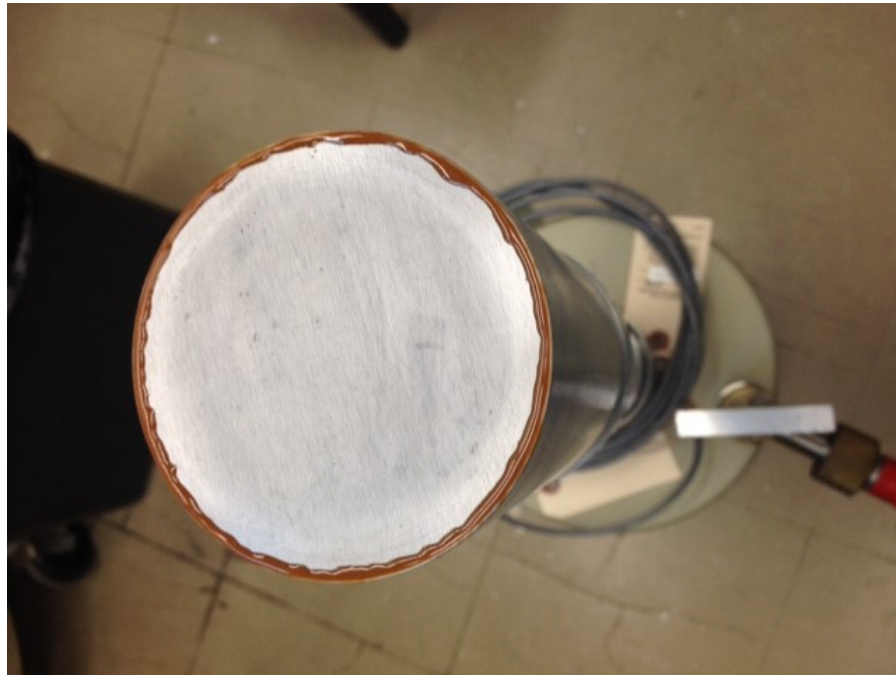
During the next 14 years, there were five more vacuum-loss incidents, each handled the same way and each leaving the detector’s efficiency unaltered. However, starting in 2016, the seal of the Be window appeared to be in a less stable situation: during that year alone we performed four interventions. While each patch appeared to work, it nevertheless ended up in a vacuum loss after a few months.

**FIG. 1.** Externally patched epoxy seal of the Be window in early 2017.

In the spring of 2017, we completely removed all the old epoxy and added a thin fresh layer of low-vapor-pressure epoxy (see Fig. 1). Again, we leak checked, re-cooled the detector and returned it to use. At that point though, we started monitoring the temperature of the crystal, using the ORTEC calibrated thermal element. This allowed us to effectively monitor the pressure and prevent unexpected shut-downs. Subsequently when the temperature (consequently, pressure) rose to near the shut-down threshold ( $\sim -160^\circ\text{C}$ ), we intervened to pump the detector out. On no occasion was there any indication of a leak in the Be window seal. Fig. 2 shows the evolution of the crystal temperature after each pumping.

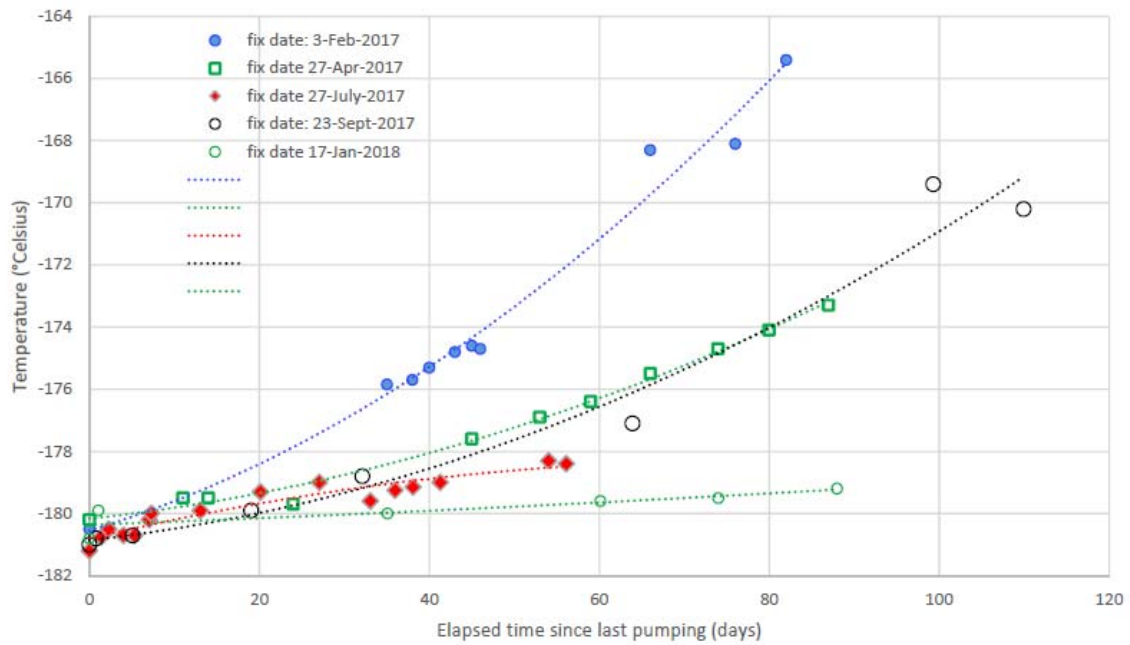
**FIG. 2.** Evolution of the HPGe temperature post vacuum-intervention in 2017 and 2018.

We performed three more (preventive) vacuum restorations during 2017. Since no significant leak was detected, we concluded that the increased heating rate was related to a reduced capacity of the molecular sieve to maintain the required high vacuum. As these interventions were preventive, we did not expect any negative impact on the detector's performance. However, each intervention increased the time required to bias the detector after cool-down: from a few minutes, to hours, then days. Thus, the last 2017 intervention required 4 steps to bias the HPGe to the nominal voltage of -4300 V: The step limits were -3200, -3700, -4100, and -4300 V. In each step we biased the detector to the maximum voltage it could sustain with normal energy-resolution, leaving it for several hours at that voltage before moving to the next step.

Clearly something had to be done to restore the effectiveness of the molecular sieve. Heating it to high temperature was out of the question since that would have seriously compromised our detector's performance, so in January 2018 we tried a "minimal" cure. With the detector operating normally, we stopped the LN cooling and brought the detector to room temperature while continuously pumping. We then continued pumping for five days, considerably longer than ever before. This time, after the detector had been cooled again it behaved normally: only a few minutes was required to bring the bias to the nominal -4300 V. Moreover, the evolution of the crystal temperature (see Fig. 2) indicates a partial restoration of the pumping capacity of the molecular sieve: The temperature increases at a rate of 0.1°C/week, much less than after previous fixes.
