Repair of the H⁻ ion source

H. Clark, B.T. Roeder, D.P. May, G. Kim, F. Abegglan, H. Peeler, and G. Tabacaru

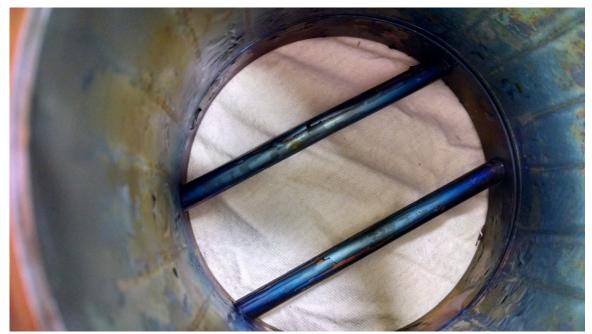
In December 2014, a water leak was discovered in the H-minus ion source. The source of the water leak was a small hole in one of the water cooling lines that make up the magnetic filter part of the source mentioned above. A picture of the magnetic filter region of the ion source before the repair is shown in Fig. 1.

FIG. 1. Picture of the inside of H^- ion source plasma chamber with the tantalum filament removed. The magnetic filter region is formed by the field from small permanent magnets housed in the two copper water cooling lines that pass through the middle of the chamber near the source exit. The damaged water cooling line is the upper pipe in the picture.

To repair the leak, the upper cooling line shown in the figure was removed. The first idea for the repair was to try to plug the hole with solder or similar material, but the heating process would likely damage the permanent magnet that was housed on the inside of the cooling line. Also, when the magnet was removed from the damaged copper line, it was found to be broken and severely corroded. In the end, it was decided to make a new cooling line with a new permanent magnet embedded in the middle. We found that we had purchased some replacement permanent magnets during the original installation of the ion source. The magnets are made of SmCo₅, and are held in place in the middle of the cooling line where they are kept cool with low-conductivity water. The new cooling line consists of two of the replacement SmCo₅ magnets super-glued together pole to pole on a thin rod of Inconel. The resulting rod was then mounted in the middle of the new copper cooling line and reinserted into the plasma chamber of the H^T ion source. Finally, the north poles of both of the magnetic filter permanent magnets were aligned in the same direction and perpendicular to the path of the extracted H^T beam. The new cooling line installed in the magnetic filter region of the source is shown in figure 2. When the ion source was reassembled, the inside of the plasma chamber was also thoroughly cleaned to remove the deposits that had built up on the walls.

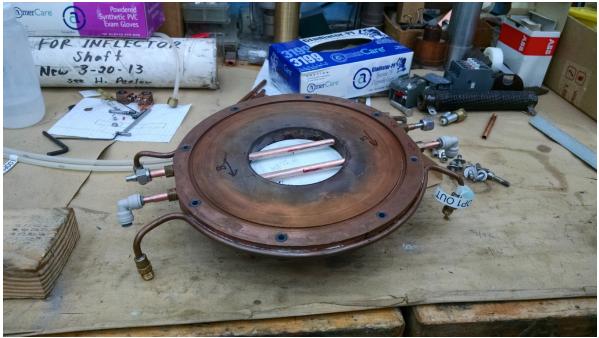
FIG. 2. The new cooling line installed in the magnetic filter region of the H^- source. The north poles of the permanent magnets are aligned perpendicular to the path of the extracted beam as shown above.

As a result of the repair, the H⁻ ion source is again operational and is producing H⁻ ions with intensities similar to those observed previously. However, the extraction optics of the ion source have changed slightly now that the new permanent magnet has been installed. This slight change does not significantly affect the performance of the ion source.
