Texas A&M cyclotron K150 radiation effects facility

April 1, 2018 – March 31, 2019

H.L. Clark, B. Hyman, and J. Thomas

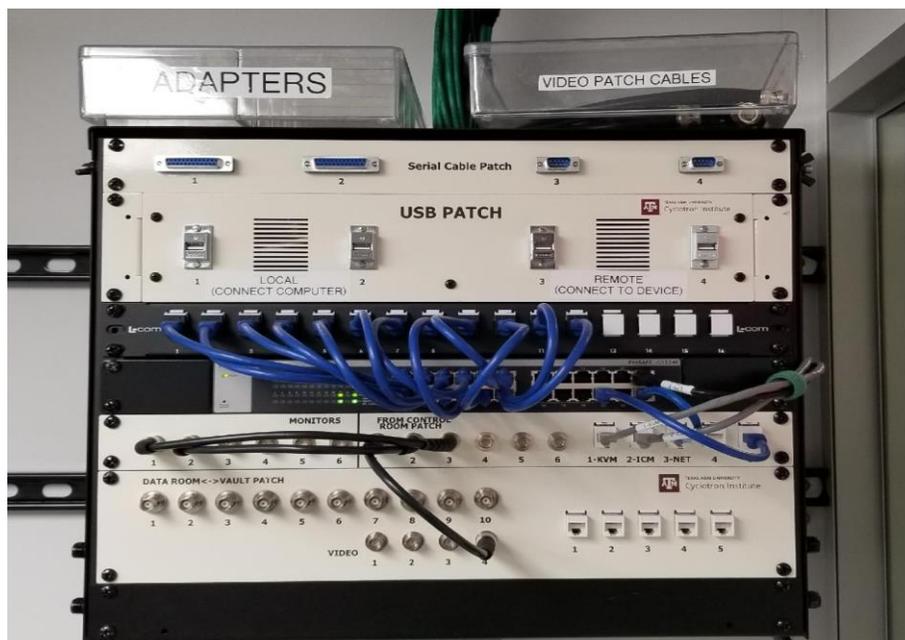
FIG. 1. Network, computer, and data patch for communication between K150 Data Room, K150 Radiation Effects Beamline, and the Control Room.

A data room and staging area have been constructed for use with the K150 Radiation Effects beamline. The new data room and setup area are located on the second floor between the K150 hi-bay and the office side of the Cyclotron Institute building. The data room is positioned above the entrance to the K150 vault allowing for short cabling distances between user equipment operated in the data room and their devices under test (DUTs). A patch panel has been installed in the data room with a companion patch panel located near the end of the beam line in the K150 vault. The panels include two DSUB-9 serial connections, two DSUB-25 serial connections, four usb 2.0 connections, ten BNC signal cable connections (RG-58), four BNC video cable (RG-59) connections, and five RJ45 jacks (CAT6 cable) (Fig. 1). The room is equipped with seven monitors, four for video feeds and three for customer computer

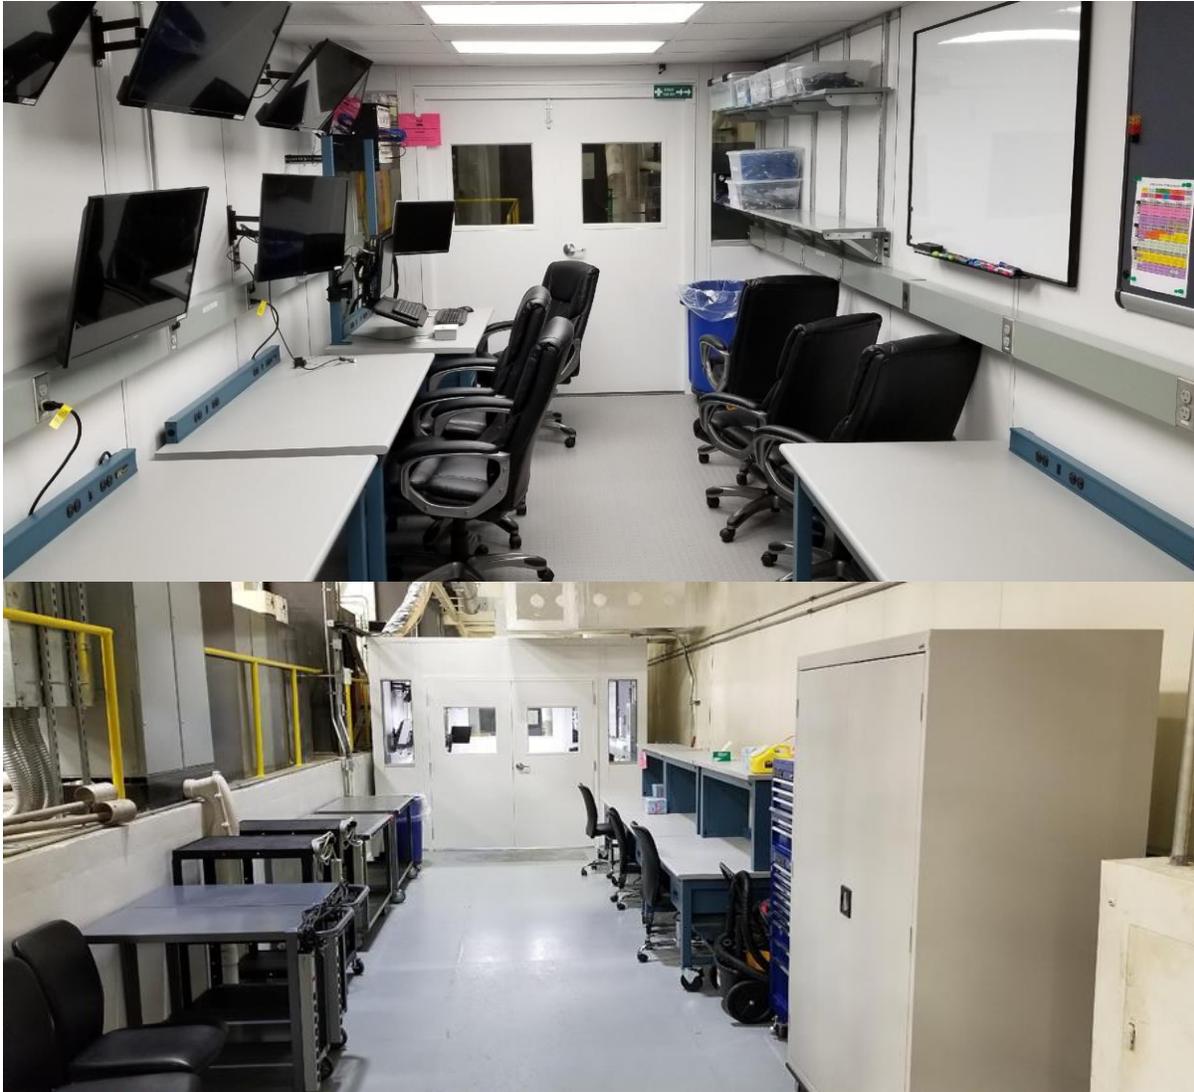
FIG. 2. (Top) Full view of the inside of the K150 Data Room. (Bottom) K150 Radiation Effects Staging Area. Carts and extra chairs for larger testing groups. The entrance of the K150 Data Room. Work surfaces with overhead work lights, Shop-Vac, tool box, and equipment cabinet.

use. Work tables and chairs are also provided for testing needs (Fig. 2). A supply of USB, BNC, HDMI, and CAT6 cables of various lengths are also available if needed. Two cameras have been installed and integrated into our video system. For safety, these are viewable in the K150 control room. Fourteen hardwired network connections have been installed so that customers can connect to our computer network. Wireless network connections to the TAMULINK network are also available if needed.

A small staging area has been set up just outside the south exit of the new data room. This area is used to accommodate customers who need space to prepare their DUTs or just a place to work outside of the data room. The area has three workbenches (with overhead lights) and includes a stocked tool box and equipment cabinet. Carts for transporting equipment between the staging area and the K150 vault are also provided (Fig. 2). A refrigerator, microwave oven, and coffee maker are also provided for customer use. A new secured door was installed for access to the freight elevator located in the office side of the building. This allows for equipment to be moved between the data room and the K150 vault as needed.
